# Fatigue damage tolerance of two tapered composite patch configurations

Chao Wu<sup>a,b</sup>, Andrew J. Gunnion<sup>b,c</sup>, Bernard Chen<sup>a</sup>, Wenyi Yan<sup>a,\*</sup>

<sup>a</sup> Department of Mechanical and Aerospace Engineering, Monash University, Clayton, Vic. 3168, Australia

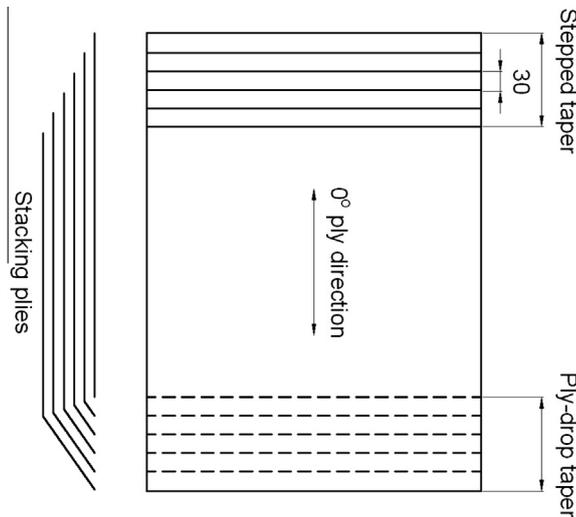
**Fig. 1.** Schematic of tapered panel manufacture.

Two types of doubler repair were selected. The first configuration (referred to as a “stepped taper” herein) is achieved by terminating each successive ply in the patch at a fixed distance short of the preceding ply. With this configuration, the first ply of the repair (adjacent to the bondline) is the longest ply. The second configuration (referred to as a “ply-drop taper” herein) is achieved with the shortest ply being placed adjacent to the bondline and each subsequent ply extending a fixed length beyond the preceding ply. The recommended doubler design is generally the ply-drop doubler, however there may be instances where the stepped doubler configuration is adopted, particularly if laminating/bonding pre-cured straps (e.g. battle damage repair [25]). The doubler panel was manufactured by staggering equal-size plies with a 3 mm offset to achieve the stepped taper at one end, and the ply-drop taper at the other, as shown in Fig. 1.

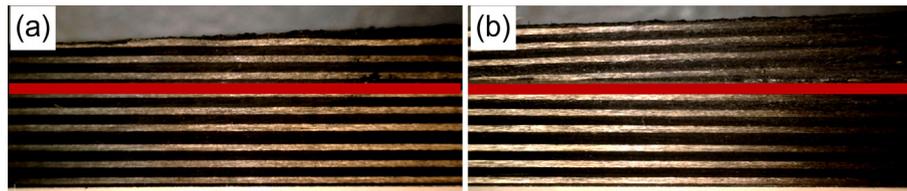
**Fig. 2.** (a) Stepped double; (b) ply-drop doubler (the red line represents the bondline). (For interpretation of the references to colour in this figure legend, the reader is referred to the web version of this article.)

of stepped and ply-drop doublers are shown in Fig. 2, with the doubler repair above the bondline (red line in Fig. 2) and parent laminate under the bondline.

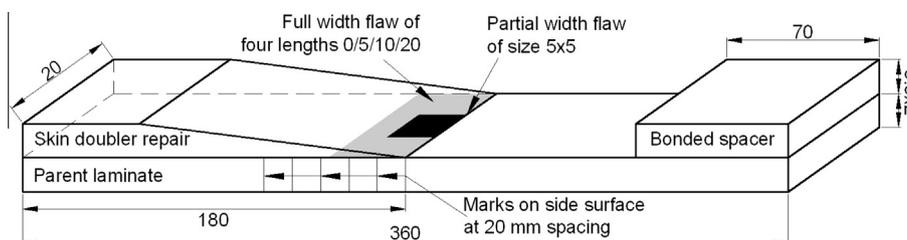
**Fig. 3.** Detailed dimensions of the skin doubler repaired specimen, and location and dimensions of the full width flaw and partial width flaw (unit in mm).

The two models had the same geometry as shown in Fig. 3. The left end of the specimen was fixed in all directions and the right end was also fixed in all directions except the movement in longitudinal direction of the specimen. A load of 18.7 kN was applied at the right end of the specimen simulating the maximum fatigue loading in the experiments (for the reference of the left and right ends, please see Fig. 3). The energy release rate ( $G$ ) at the tip of the first 0° ply of the doubler was calculated based on the contour integral method in Abaqus, assuming a small initial crack of 0.5 mm at the location of interest (see Fig. 13). In the following discussions,  $G_0$  means the energy release rate of the stepped doubler without initial bondline flaw and  $G_5$  is the energy release rate of the stepped doubler with a 5 mm initial bondline flaw. The FE results showed that the specimen without an initial bondline flaw had an energy release rate ( $G_0$ ) of 230 J/m<sup>2</sup> at the tip of the first 0° ply. In contrast, the 5 mm initial bondline flaw effectively unloaded this critical location in the patch, resulting in an energy release rate ( $G_5$ ) value of only 1.42 J/m<sup>2</sup>.

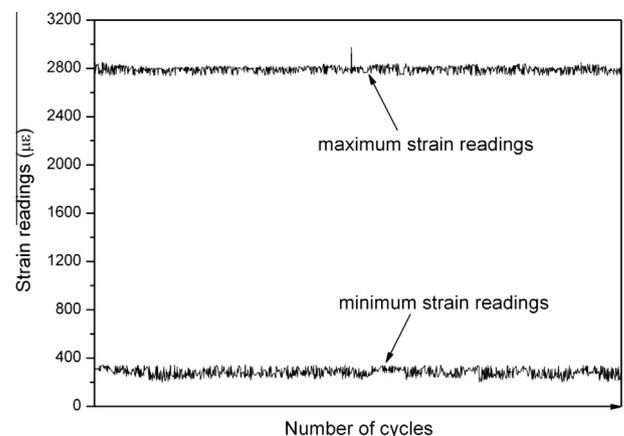
**Fig. 4.** Maximum and minimum strain readings against the number of cycles of specimen S-Control-2.

gauge readings were transferred by DT85 data logger from Thermo Fisher Scientific Inc. The data was configured by DeTransfer 3.27 from dataTaker Pty Ltd. Then the gauge readings were recorded by DeFriend 2.6.1 program. The strain readings in Fig. 4 indicated that the required 2800  $\mu\epsilon$  was obtained at the maximum fatigue loading of 18.7 kN.

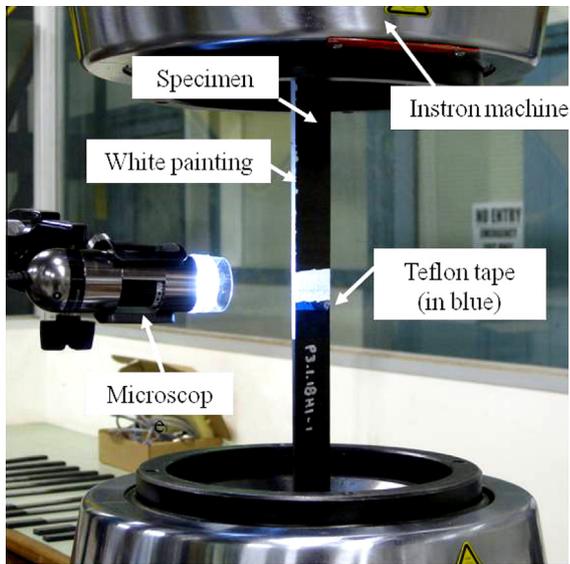
Fig. 5. Experimental set up of fatigue testing on the doubler repaired specimens.

A microscope was used to monitor the crack propagation process and measure the crack length. The microscope was AD7013MZT from Dino-Lite Digital Microscope. It can capture detailed images with up to 2592 × 1944 pixels resolution. The magnification capacity was up to 250 times. The microscope was connected to a desktop through USB connection and the images can be captured and recorded by DinoCapture 2.0 program. In order to monitor the crack propagation during the fatigue loading using the microscope, one side of each skin doubler repaired specimen was painted in white using a correction pen. Six marks were made on the white painting with a spacing of 20 mm, with the first mark denoted the location of the doubler tip (see Fig. 3). The fatigue life of each specimen was defined as the number of cycles when the crack reached the final mark (100 mm from doubler tip). If there was no crack growth or the crack grew but did not reach the length of 100 mm, the fatigue loading was applied continuously up to six lifetimes (180,000 cycles). The experimental setup of the fatigue tests is shown in Fig. 5.

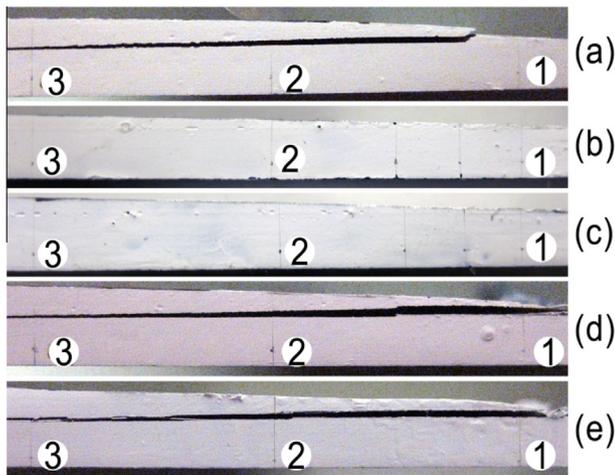
Fig. 6. Failure modes of specimens with stepped doubler repair with a flaw size of (a) without initial flaw; (b)  $5 \times 5 \text{ mm}^2$ ; (c)  $5 \times 20 \text{ mm}^2$ ; (d)  $10 \times 20 \text{ mm}^2$ ; (e)  $20 \times 20 \text{ mm}^2$ .

For failed specimens, it can be seen in Figs. 6 and 7 that the crack started from the initial embedded flaw and propagated along

the adhesive bondline for both stepped and ply-drop doubler repaired specimens. One observation which needs special attention is for stepped doubler specimen without an initial flaw. The specimen failed with the crack initiated some distance away from the doubler tip (Fig. 6a). For specimens that did not fail (i.e. exceeding 180,000 cycles) no crack growth was visible (see Figs. 6b, c and 7a–c). Detailed microscope investigations on the crack initiation and propagation patterns will be presented in Section 3.3.

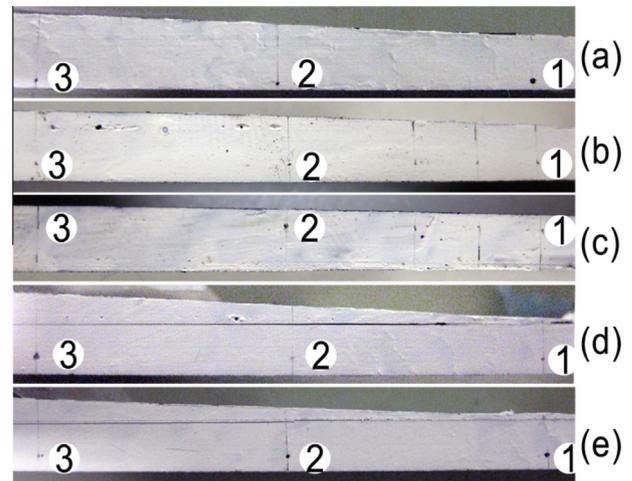
Fig. 7. Failure modes of specimens with ply-drop doubler repair with a flaw size of (a) without initial flaw; (b)  $5 \times 5 \text{ mm}^2$ ; (c)  $5 \times 20 \text{ mm}^2$ ; (d)  $10 \times 20 \text{ mm}^2$ ; (e)  $20 \times 20 \text{ mm}^2$ .

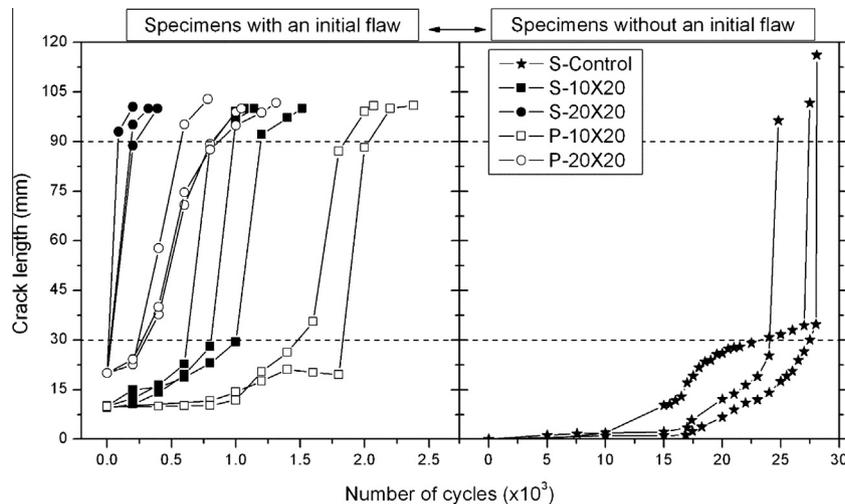
Fig. 8. Crack propagation of failed stepped doubler (solid symbols) and ply-drop doubler (hollow symbols) repaired specimens.

The crack propagation process of the failed specimens was recorded and measured by the microscope. The measured crack propagation length against the corresponding number of cycles was plotted in Fig. 8. The left side of Fig. 8 shows the crack propagation curves of failed specimens with an initial flaw ( $10 \times 20 \text{ mm}^2$  or  $20 \times 20 \text{ mm}^2$  size), and the right side presents the crack propagation curves of specimens (stepped doubler) without an initial flaw. It should be noted that, the crack length in Fig. 8 was

measured from the tip of doubler repair including the length of the initial flaw.

For failed specimens with an initial flaw, a three-stage crack propagation process was identified from the left side of Fig. 8. In the first stage, the crack grew slowly before it reached a length of about 30 mm. In the second stage, the crack growth became unstable after it exceeded 30 mm and it grew rapidly until 90 mm. Finally, the crack growth rate reduced again until the final 100 mm length was reached. For stepped doubler repaired specimens without an initial flaw (right side of Fig. 8), a two-stage crack propagation process was observed, with the crack firstly grew slowly until 30 mm after which the crack growth became unstable. The reduction of crack growth rate (as shown in the third stage of specimens with an initial flaw) was not observed for specimens without an initial flaw. It seems that for both stepped and ply-drop doubler repaired specimens in the current study, 30 mm is a critical crack length beyond which catastrophic bondline failure becomes inevitable. In addition, stepped doubler repaired specimens with an initial flaw of 20 mm long (S- $20 \times 20$ ) failed rapidly as soon as the fatigue load was applied, without experiencing the first stage of slow crack growth.

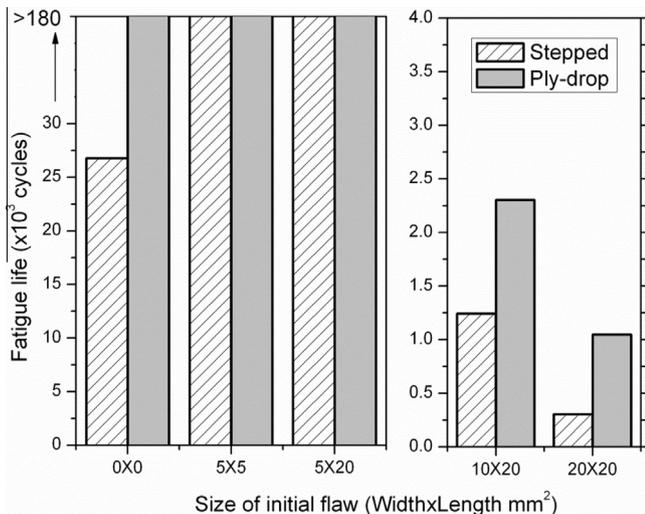
Fig. 9. Average fatigue life versus size of initial flaw for stepped and ply-drop doubler repaired specimens.

The fatigue life of each failed specimen was defined as the number of cycles when the crack reached 100 mm length (measured from the tip of the doubler repair). The fatigue life of each specimen is listed in Table 2. When the specimen survived six lifetimes, its fatigue life is denoted as '>180,000' cycles in Table 2. The fatigue lives of three identical specimens are averaged and plotted against the size of initial flaw for stepped and ply-drop doubler repaired specimens in Fig. 9.

As can be seen from Table 2 and Fig. 9, there is a general trend that the fatigue life decreases with the increase of initial flaw size for both stepped and ply-drop doubler repaired specimens. It is also obvious from Table 2 and Fig. 9 that, ply-drop doubler repair performed better than stepped doubler repair in terms of damage tolerance under fatigue loading. For example, the ply-drop doubler repair without an initial flaw (P-Control) survived after six lifetimes (>180,000 cycles), comparing to the stepped doubler counterpart (S-Control) which failed at an average fatigue life of 26,786 cycles. Both stepped and ply-drop doubler repaired specimens survived six lifetimes (>180,000 cycles) when the imbedded flaw length was 5 mm. At an initial flaw size of  $10 \times 20 \text{ mm}^2$ , the ply-drop doubler repair (P- $10 \times 20$ ) achieved an average fatigue life of 2,305 cycles, which is almost twice the average fatigue life (1,242 cycles) of the stepped doubler repair (S- $10 \times 20$ ). When

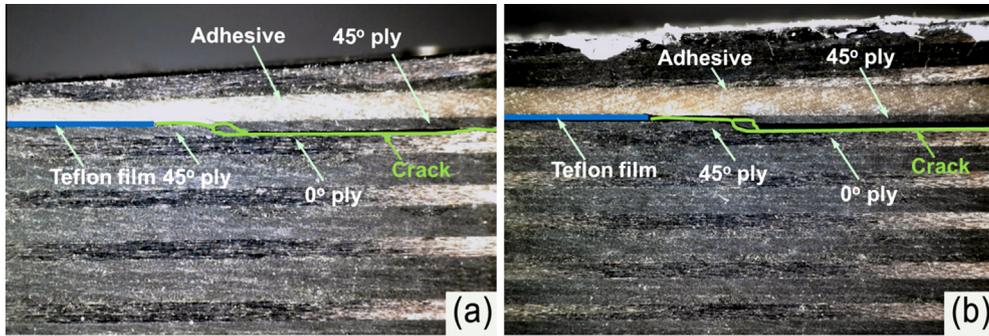
Fig. 10. Crack initiation and propagation pattern of failed ply-drop doubler repaired specimens with an initial flaw of (a)  $10 \times 20 \text{ mm}^2$  and (b)  $20 \times 20 \text{ mm}^2$ .

Microscope AD7013MZT from Dino-Lite Digital Microscope was used to investigate the detailed crack initiation and propagation patterns of failed specimens. The magnification of the microscope was 50 times at a resolution of  $1280 \times 960$  pixels. The crack initiation and propagation patterns for failed ply-drop doubler repaired specimens are presented in Fig. 10, where the initial flaw (Teflon tape) is highlighted by a blue<sup>1</sup> line and the crack is indicated by green lines. As can be seen in Fig. 10, the crack initiated from the tip of the Teflon film, then grew at the interface between the adhesive and the  $45^\circ$  ply of the parent laminate. After a short while, the crack passed the  $45^\circ$  ply and propagated at the interface between  $45^\circ$  and  $0^\circ$  plies in the adherend laminate.

According to the microscope observations shown in Figs. 10–12, several conclusions can be drawn: firstly, when there was an initial bondline flaw of the size  $10 \times 20 \text{ mm}^2$  or  $20 \times 20 \text{ mm}^2$ , both stepped and ply-drop doubler repaired specimens experience the

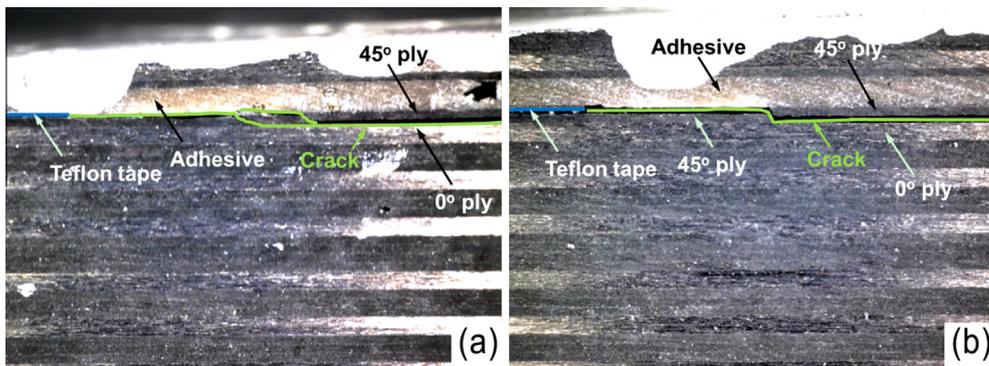
Fig. 11. Crack initiation and propagation pattern of failed stepped doubler repaired specimens with an initial flaw of (a)  $10 \times 20 \text{ mm}^2$  and (b)  $20 \times 20 \text{ mm}^2$ .

The crack initiation and propagation patterns of failed stepped doubler repaired specimens with an initial flaw of  $10 \times 20 \text{ mm}^2$  or  $20 \times 20 \text{ mm}^2$  are shown in Fig. 11. Similar to failed ply-drop doubler repaired specimens with the same size of initial flaw, the crack also started from the tip of Teflon tape and grew at the interface between the adhesive and the  $45^\circ$  ply of the parent laminate. The crack passed the  $45^\circ$  ply shortly and propagated at the interface between  $45^\circ$  ply and  $0^\circ$  ply of the adherend laminate till failure.

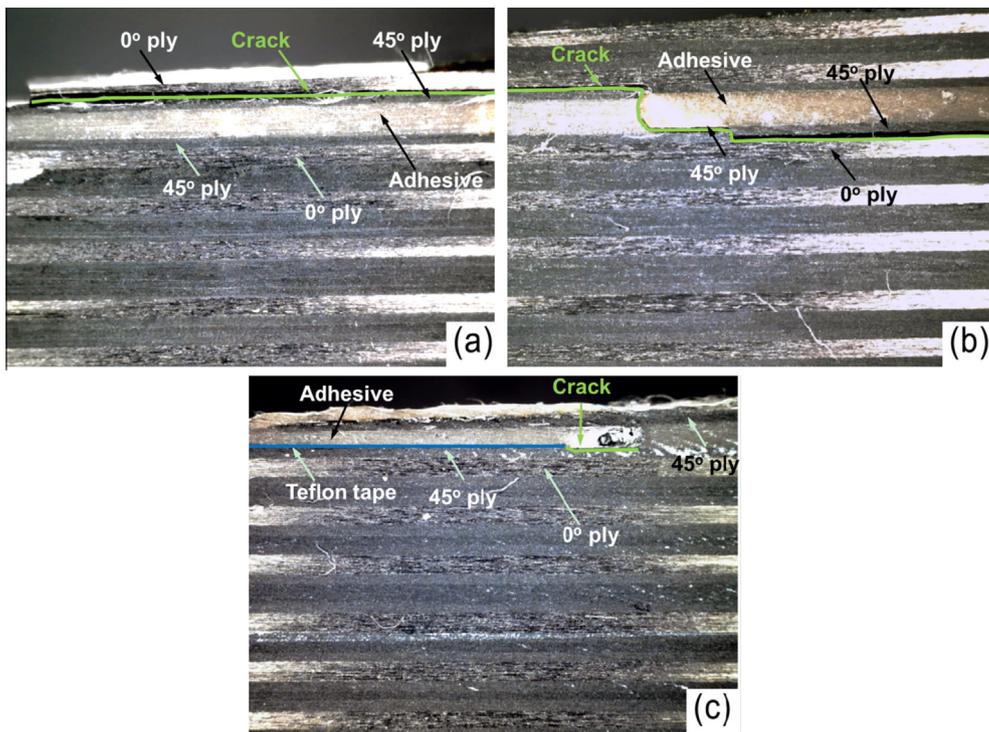
Fig. 12. (a) Crack initiation and propagation pattern of stepped doubler repaired specimens, (b) without an initial flaw and (c) with an initial flaw of  $5 \times 20 \text{ mm}^2$ .

A different crack initiation and propagation pattern of failed stepped doubler repaired specimen without an initial flaw is identified in Fig. 12(a) and (b). When there is no initial flaw, the crack initiated from the tip of the first  $0^\circ$  ply in the doubler (Fig. 12a) adjacent to the adhesive bondline. The crack then grew at the interface between the  $0^\circ$  ply and the  $45^\circ$  ply in the doubler for a while, before it passed the  $45^\circ$  ply in the doubler and entered the adhesive bondline (Fig. 12b). After passing the adhesive bondline, the crack grew a short distance at the interface between the adhesive and  $45^\circ$  ply in the adherend laminate (Fig. 12b). Finally the crack steadily propagated at the interface between the  $0^\circ$  ply and  $45^\circ$  ply in the adherend laminate.

For comparison purpose, the microscope image of stepped doubler repaired specimen with an initial flaw of  $5 \times 20 \text{ mm}^2$  is presented in Fig. 12(c). As can be seen, no crack initiation or propagation was observed in the doubler repair adjacent to the adhesive bondline. The crack initiated at the tip of initial flaw and only grew a very limited distance after 180,000 cycles of fatigue loading.

between 45° ply and 0° ply in the adherend laminate until complete failure of the specimen. Secondly, when there was no embedded bondline flaw, stepped doubler repaired specimen also failed due to the crack initiation at the tip of the first 0° ply in the doubler adjacent to the adhesive bondline. After a short distance propagation at the interface between 0° ply and 45° ply in the doubler, the crack passed the adhesive bondline and finally entered and grew at the interface between 45° ply and 0° ply in the adherend laminate. Thirdly, when an initial bondline flaw with a length of 5 mm was introduced in the stepped doubler repair, the tendency of crack initiation in the doubler was suppressed. Instead, the crack initiated at the flaw tip and only grew for a limited length under the fatigue loading up to 180,000 cycles. It seems that the introduction of an initial bondline flaw of 5 mm length suppressed the crack initiation tendency in the doubler.

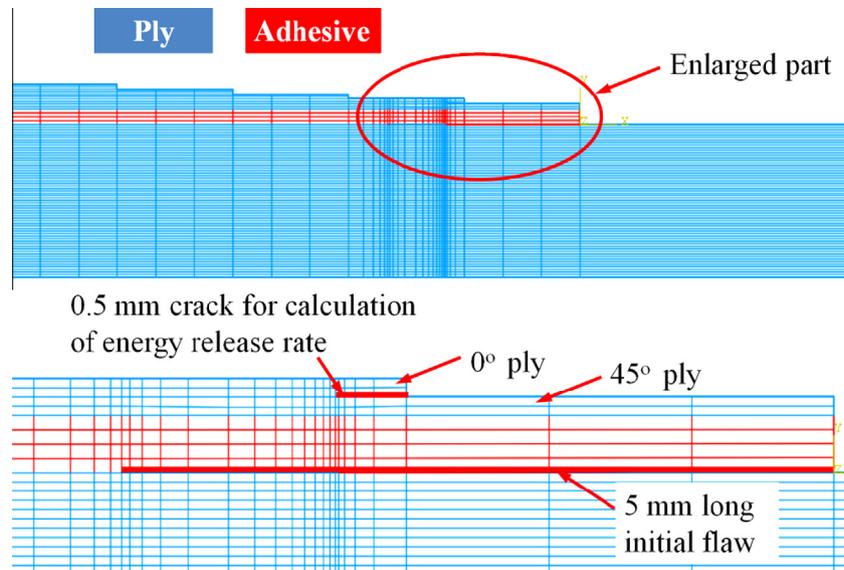
Fig. 13. Mesh details and crack geometries (model with 5 mm initial flaw).

was stepped doubler with a 5 mm initial flaw. In both models, 8-node linear brick elements, C3D8R, with reduced integration were used for both ply and adhesive materials. Two elements were used for each ply and four elements for the adhesive bondline (see Fig. 13) which was determined through mesh sensitivity study. The material properties of a ply as listed in Table 1 were adopted in both FE models. For the adhesive FM300-2K, its stress strain relationship under room temperature as shown in Fig. 14 was used [29].

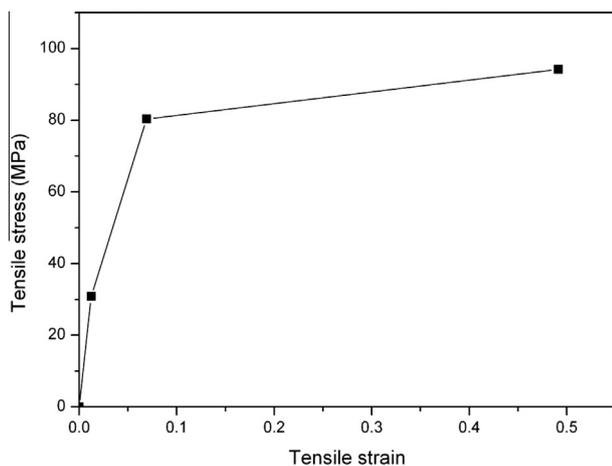
Fig. 14. Stress–strain relationship of adhesive FM300-2K in FE models.
